# LOUISIANA DEPARTMENT OF WILDLIFE & FISHERIES

WATERBODY MANAGEMENT PLAN SERIES

**IVAN LAKE**

LAKE HISTORY & MANAGEMENT ISSUES

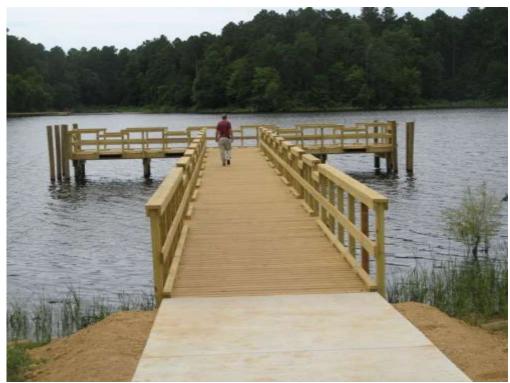
Figure 1. Handicap accessible pier. LDWF file photo.

In 2013, LDWF constructed five public fishing piers on Ivan Lake, including one ADA pier accessible by handicap parking and sidewalk (Figures 1 and 2). Three piers have been equipped with automatic fish feeders. Also, a boat mooring dock is located adjacent to the boat launch.

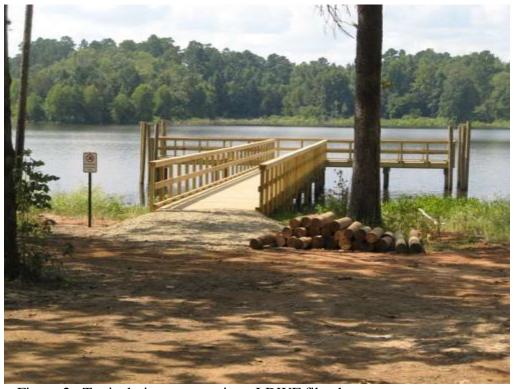
Figure 2. Typical pier construction. LDWF file photo.

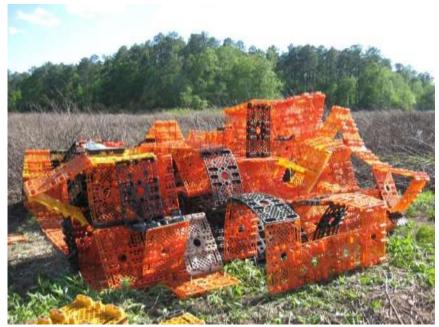
Figure 3. Plastic tower structure. LDWF file photo.

Three types of reef structures have been deployed on the lower portion of Ivan Lake: 1) Plastic crate towers, 2) Vertical Christmas trees, and 3) Pallet stake beds (Figures 3, 4 and 5). The plastic crate towers are marked by a single buoy, and the Christmas trees (70) are surrounded by four buoys aligned in a square-shaped pattern. Twenty stake bed pallets have been sunk along the perimeter of the buoys.

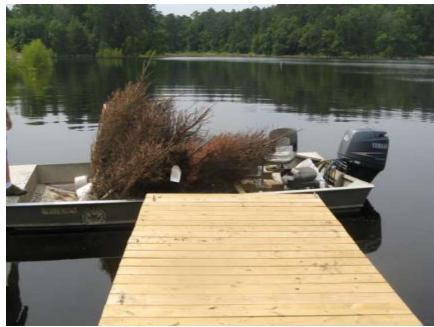
Figure 4. Christmas tree reefs. LDWF file photo.

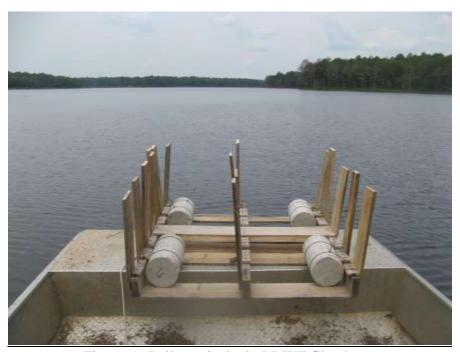
Figure 5. Pallet stake bed. LDWF file photo.

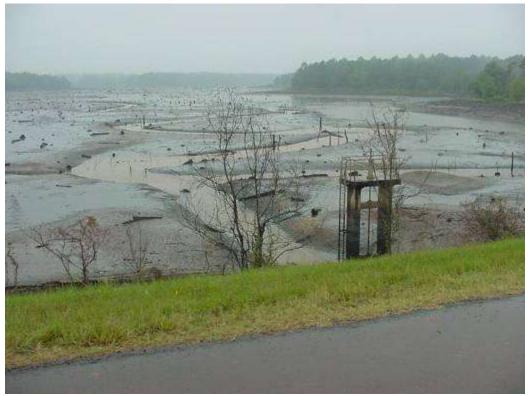
Figure 6. Ivan Lake following accidental complete dewatering in the fall of 2004. LDWF file photo.

Ivan Lake was completely dewatered in the 2004. The dewatering was unintentional. It occurred when the control structure was not closed at the proper time during a drawdown for hydrilla control (Figure 6). The drawdown was to be the first of five consecutive fall-winter drawdowns for hydrilla control in accordance with the Ivan Lake Aquatic Vegetation Management Plan prepared by LDWF. A fish kill followed this accidental dewatering, and an investigation showed a large number of sport fish died as a result of this event. Once it was discovered that the lake had been drained, DOTD was contacted, the gate were closed, and the lake was allowed to refill to the prescribed 6' drawdown level. Evaluations of the remaining fish population by LDWF personnel revealed an abundance of rough fish and few remaining sport fish.

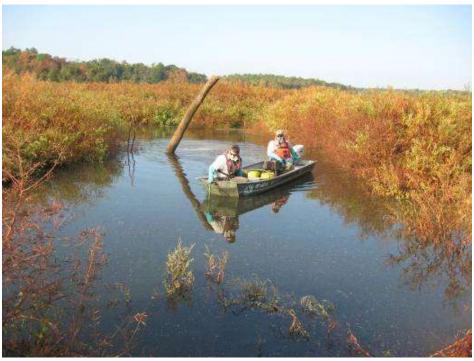
Figure 7. Application of liquid rotenone to water remaining in creek channel at maximum drawdown in an effort to eradicate the existing fish population prior to restocking following renovations to Ivan Lake. LDWF file photo taken October 12, 2010.

On October 12, 2010 an application of 5% liquid rotenone was made to the remaining pockets of water found within the lakebed (Figures 7 and 8). The application was made by LDWF personnel with assistance from local USACE personnel. This fish eradication effort was intended to remove any undesirable fish prior to future restocking efforts. Moribund fish observed following the treatment included spotted gar, bigmouth buffalo, largemouth bass, channel catfish, and gizzard shad. Several weeks after the treatment, 800 yards of 2" flag webbing was deployed in the creek and borrow pit, then checked periodically over the course of a month. One decomposed spotted gar was collected during this effort.

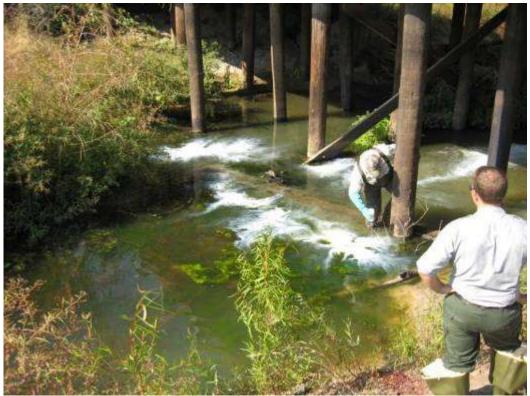
Figure 8. Liquid rotenone applied to creek channel and other areas not accessible by boat. LDWF file photo taken October 12, 2010.

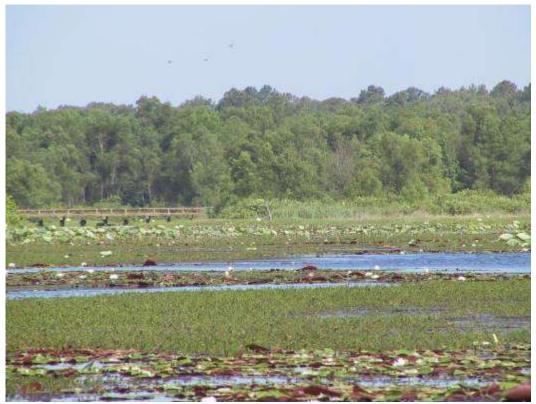
Figure 9. Aquatic vegetation is problematic in many areas of Ivan Lake due to the large expanses of shallow water. LDWF file photo.

Ivan Lake has extensive areas of shallow water that are susceptible to utilization by aquatic macrophytes (Figure 9). It is suspected that aquatic plant growth increased over time as the Ivan Lake eutrophication process accelerated.

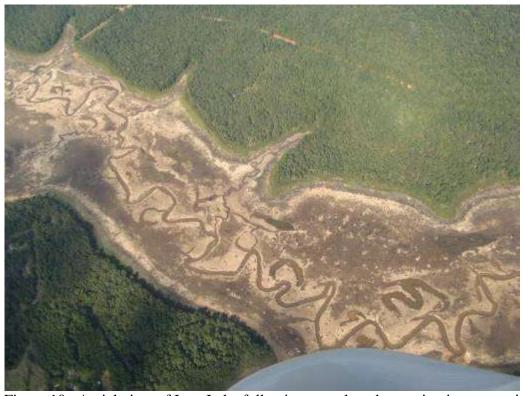
Figure 10. Aerial view of Ivan Lake following complete dewatering in preparation for lake renovations. LDWF file photo.

Hydrilla coverage was found to be greatly reduced during the 2005 vegetation survey. A determination was made to continue with the existing plan for hydrilla control and continue the drawdowns. Ivan Lake has been dewatered much of the time since 2005 for various reasons pertaining to lake renovation (see Table 1, Drawdown History section). An aerial view of Ivan Lake during one of the drawdowns from 2005 until present is shown in Figure 10.

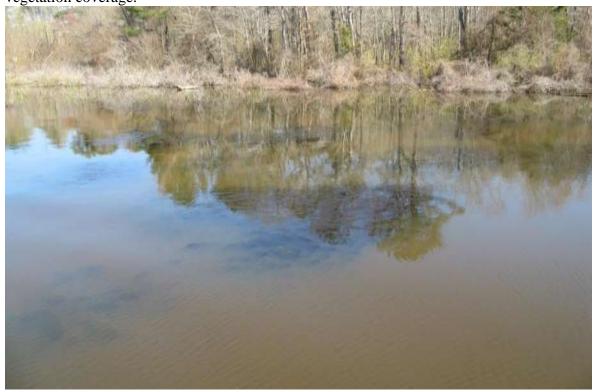
A typical shoreline view of milfoil patches in Ivan Lake & Ivan Lake submerged vegetation coverage.

Aquatic vegetation covers approximately 20-25% of Ivan Lake. While this coverage is not severe, there are dense patches of submerged vegetation around the shoreline extending approximately 40 yards from the shore. Eurasian milfoil and southern naiad are the most abundant species present (90% total coverage). The remaining coverage is a conglomeration of the species listed above. Giant salvinia was found near the boat ramp in the rocks along the dam, and a couple of pieces were found floating along the shoreline during the survey. Only a couple of hydrilla stems were observed. The total acreage affected by submerged vegetation is 121.5 acres.
